## Cleaner MHE Contact Incident

**Alert No.** HSEQ-SA-085  
**Date of issue** 22 August 2019

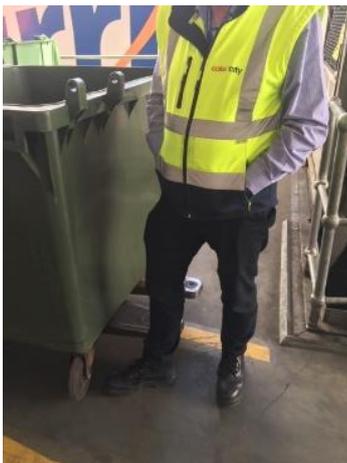
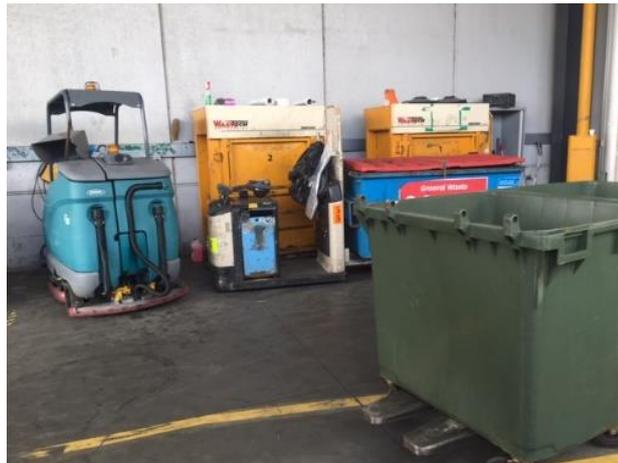
A cleaning team member was operating a LLOP in a DC compactor area. When turning the LLOP around to exit the area, the protruding tines on the back of the LLOP has brushed past and contacted another City Cleaning Team member on the ankle with the potential for serious injury.

- The turning circle of the LLOP was restricted by another LLOP that was parked in the compactor area. This forced the MHE driver to conduct a number of forward and reversing manoeuvres when turning the unit around.
- Cleaning team member standing area at the compactor control panel was not defined to prevent MHE encroaching into the area.
- 'Parking' and 'No Parking' areas were not defined in the compactor area.
- Nominated LLOP parking area not defined near the compactor that would allow MHE to park when having to empty cardboard into the compactor.

- Parking and No Parking areas defined and marked in compactor area.
- Compactor control panel area defined and marked.
- MHE operating and parking areas in compactor area reinforced with team members.
